Appendix A
Photographs of Woodstoves

Each stove involved in the study was inspected and photographed to document the stove's condition and installation. A photograph of each stove is presented in this appendix. For those stoves that showed degradation or had replacement parts, additional photographs documenting the stove's condition have been included.

Klamath Falls Photographs

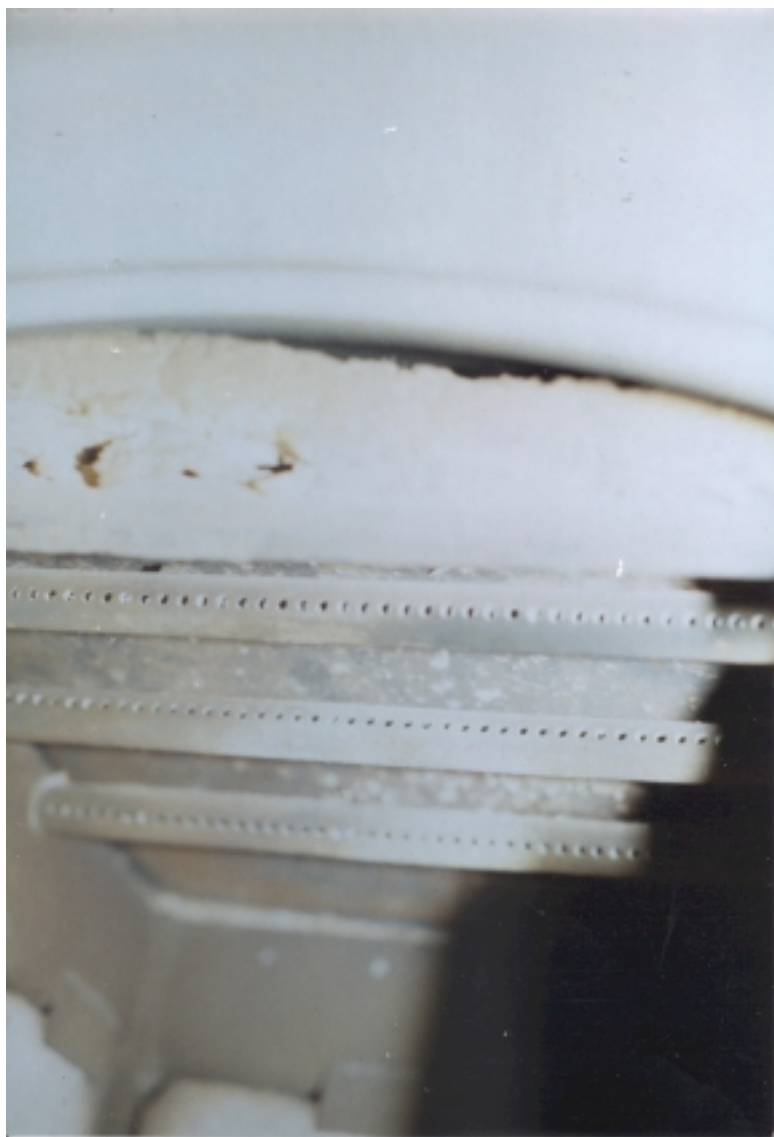
Photograph 2
KF01. Displaced Ceramic Blanket in the Non-Catalytic Quadrafire 2100

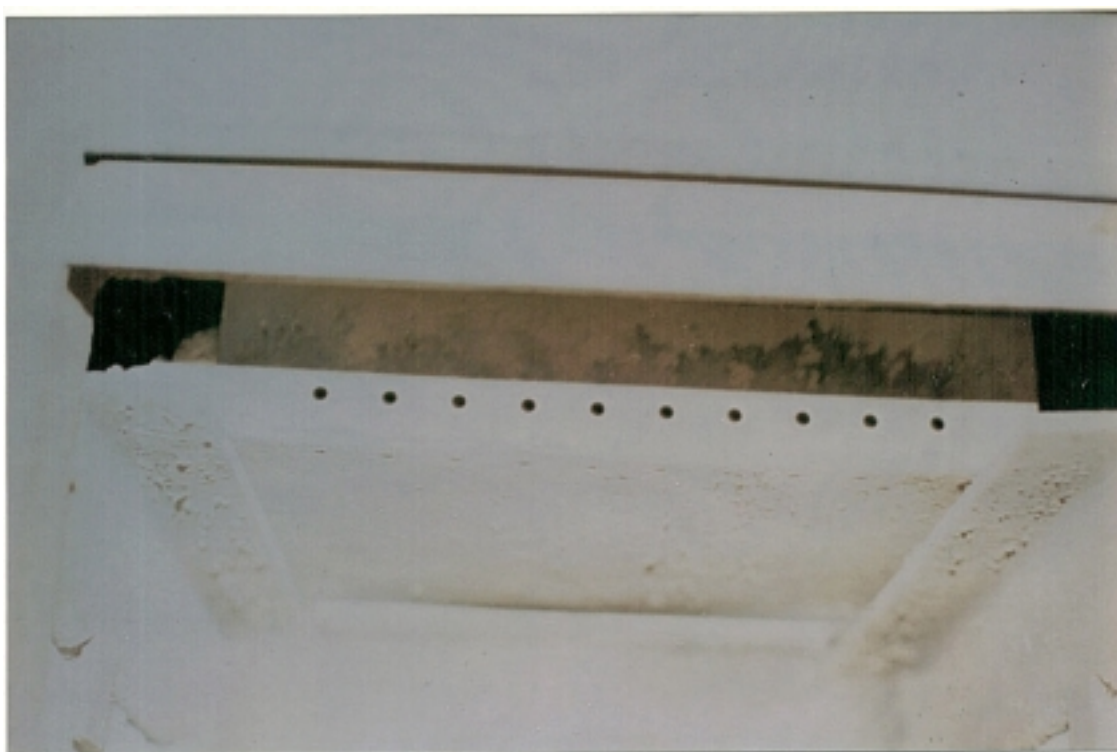
Photograph 4
KF02. Replaced Smoke Baffle in the Non-Catalytic Pacific Energy Super 27.

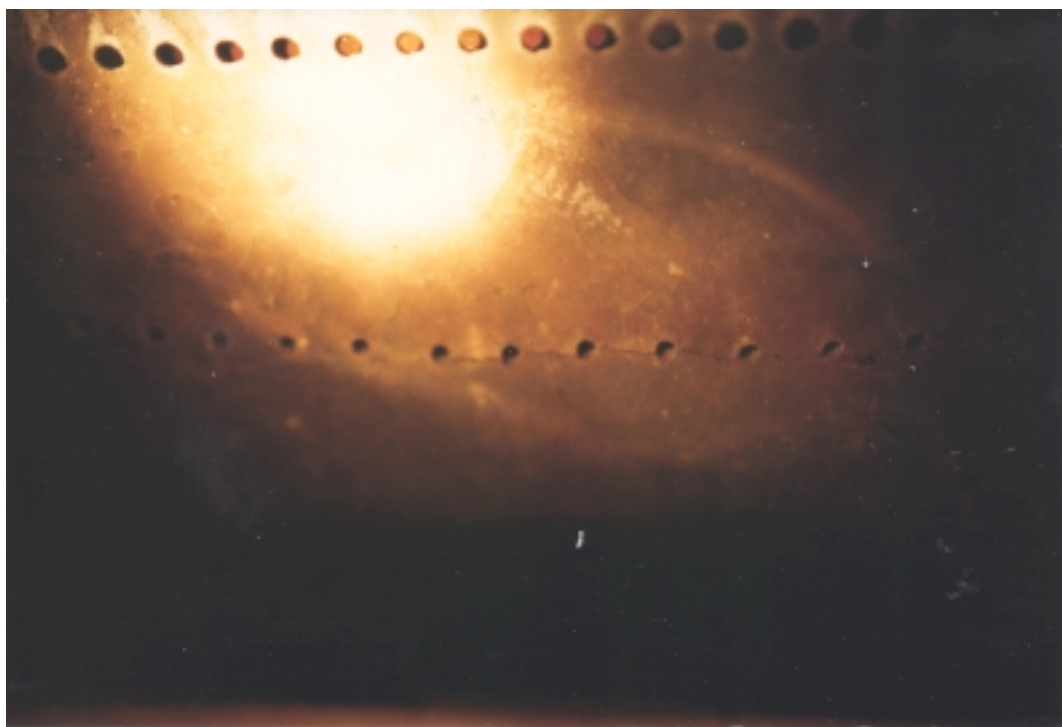
Photograph 6
KF03. Cracks in the rear secondary air ports in the non-catalytic Haughs 171E.

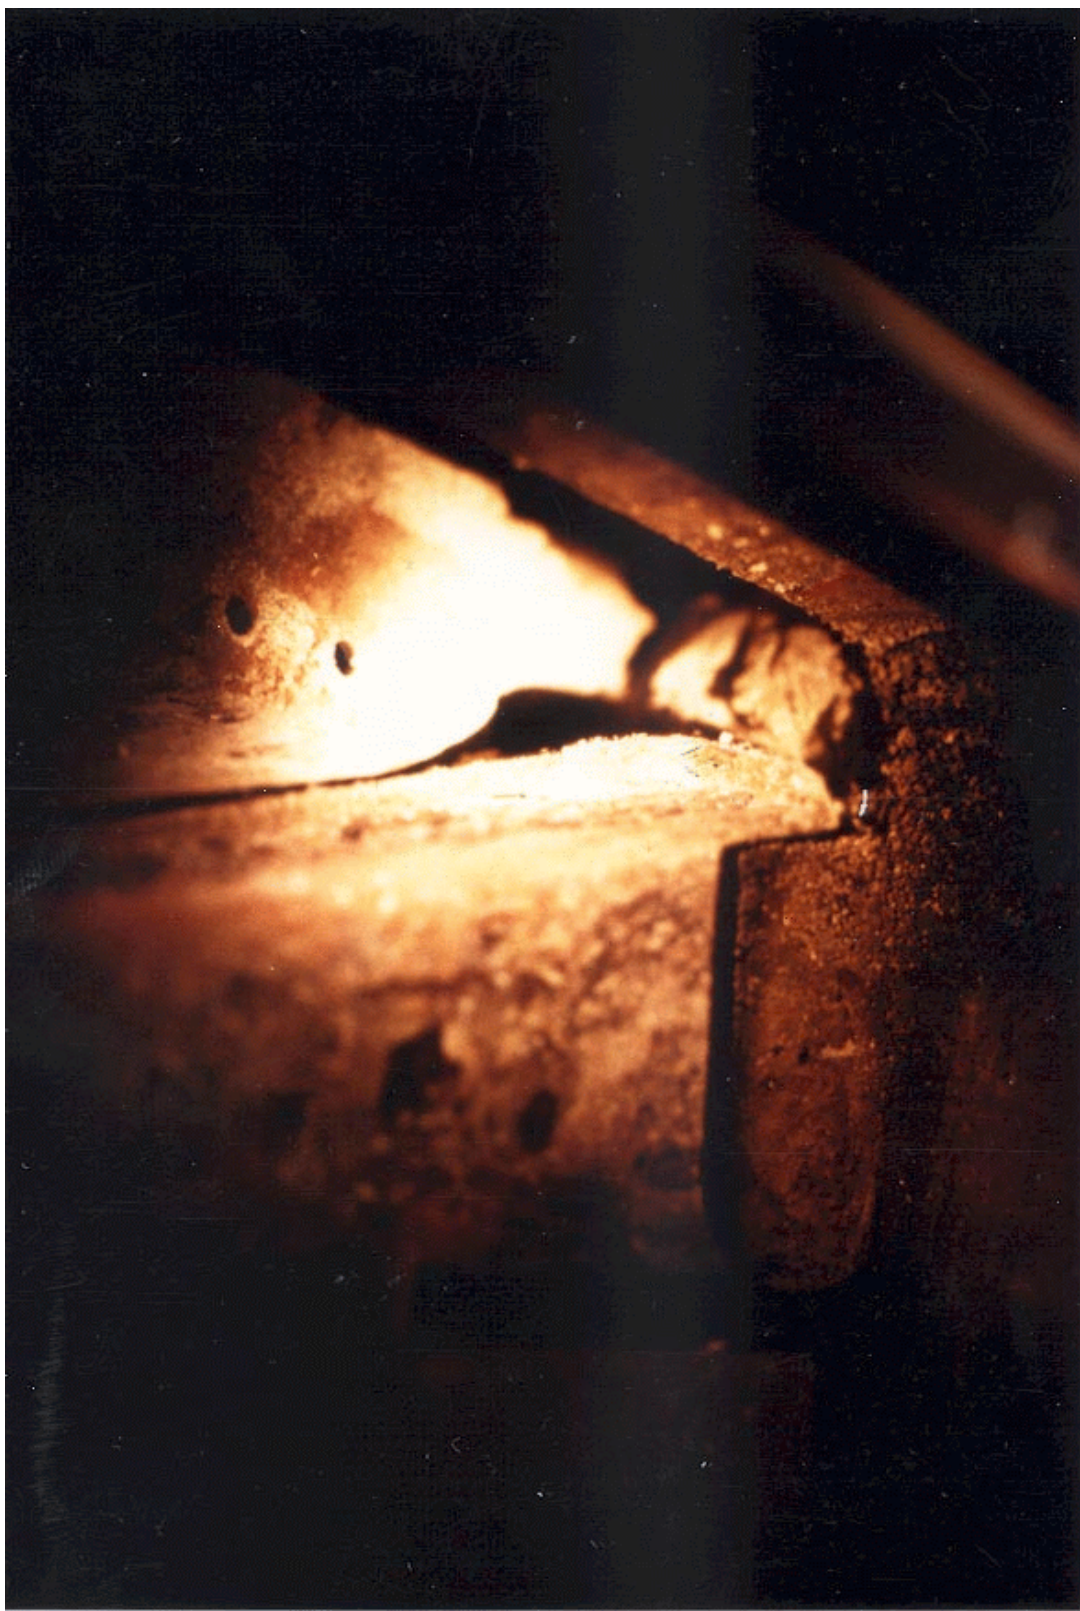
Photograph 9
KF05. Degraded baffle and ceramic blanket in the non-catalytic Pacific Energy Super 27.

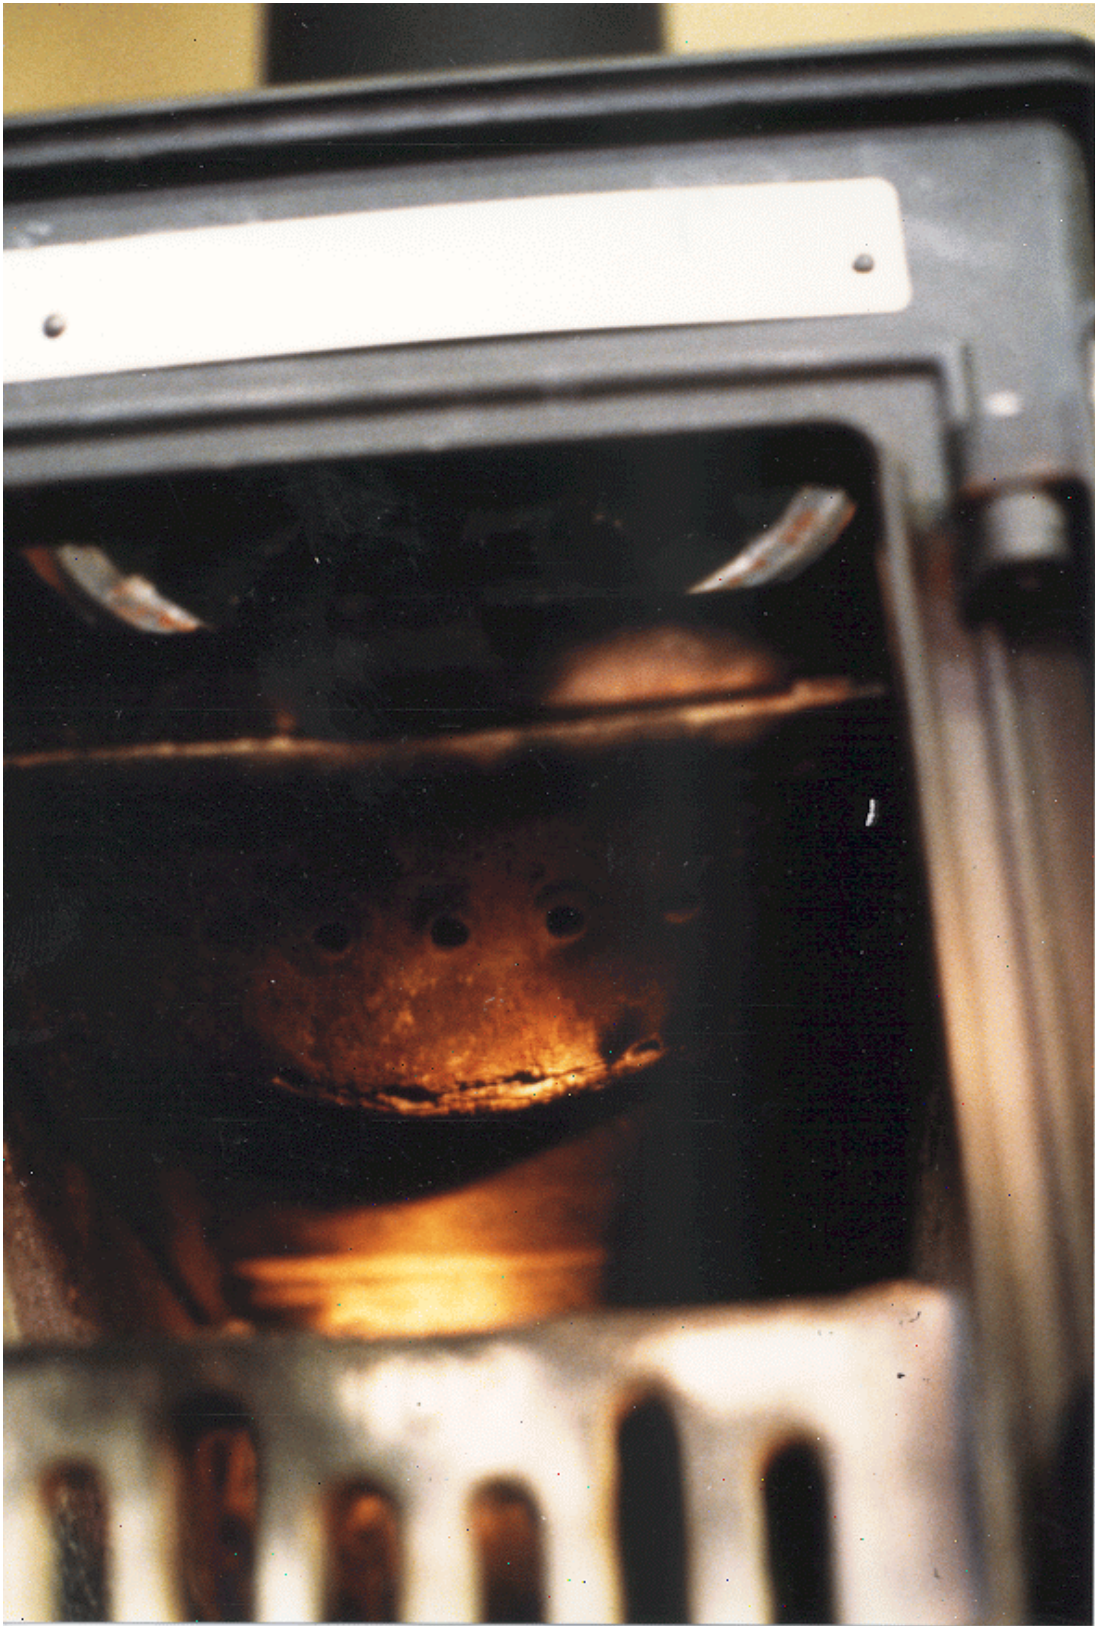
Photograph 11
KF06. Degraded baffle in the non-catalytic Waterford MKII.

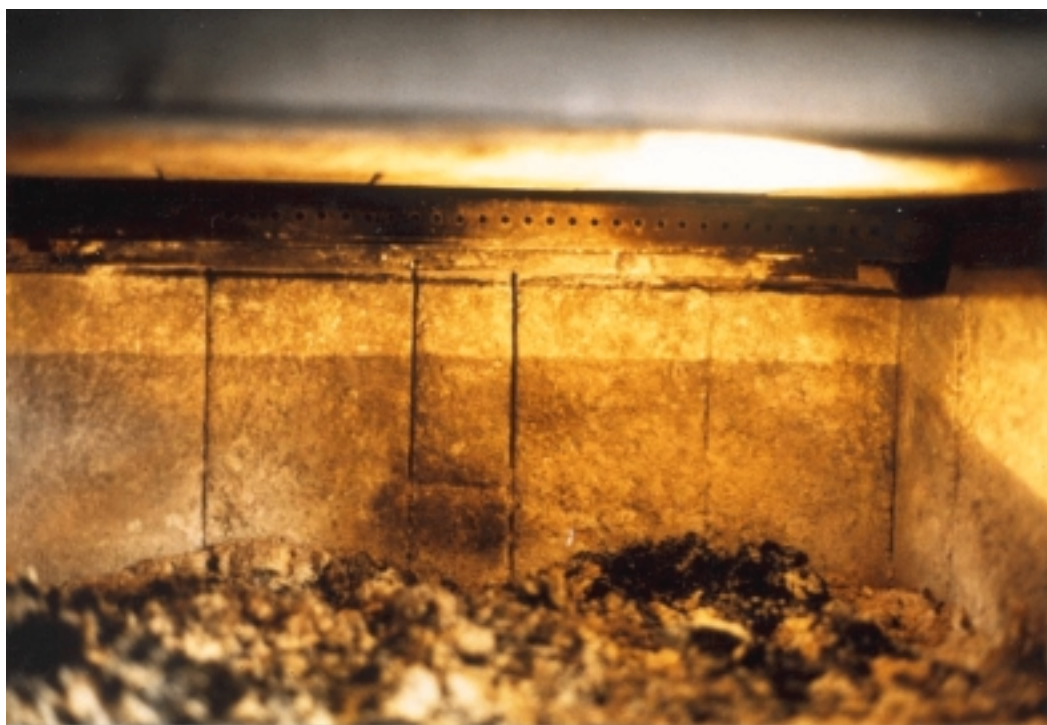
Photograph 13
KF07. Worn refractory elements in the non-catalytic Earthstove 1400HT.
